WHEATLEY DAM

(GILBERT RUN WATERSHED - SITE NO. 2)

NDI ID NO. MD-60

PHASE I INSPECTION REPORT
NATIONAL DAM INSPECTION PROGRAM

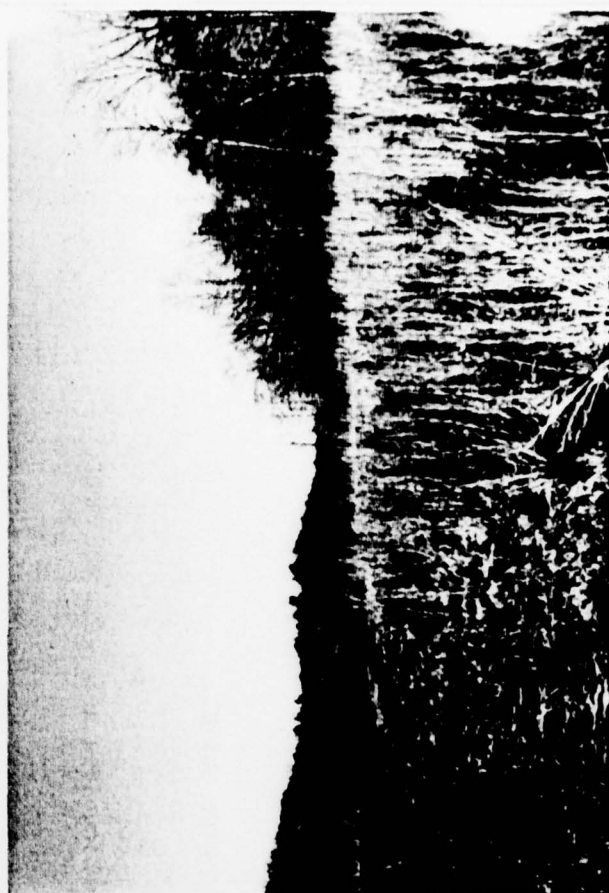
PHOTOGRAPH 4

- 2) Emergency Spillway. The emergency spillway channel is generally covered with tall, dense grass (see Photograph 4). Trees and brush were observed on the sides of the channel in some areas. Tire ruts were evident along the channel bottom and a footpath has been worn into the grass cover on the right side of the spillway channel.

- 5) Emergency Spillway. Field reconnaissance and review of design documents indicate that the emergency spillway is stable and in good condition. The tall grass covering the spillway channel may reduce discharge capacity.

Emergency spillway channel looking upstream.
